Prepared for: Sally Buyer

Address: 1234 That Street  
Santa Fe, NM 87507

July 6, 2016

**Moya Home Inspection**  
P.O. Box 28908  
Santa Fe NM 87592  
505-216-0813

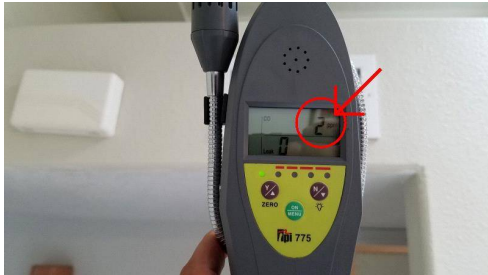
##### *11.9 Carbon Monoxide Tested:*

1. Action Needed - Measurable amounts of carbon monoxide were noted from the registers. A hazardous condition may exist. Thebinsoectie noted readings of 1-3 PPM. Further testing and evaluation are needed.

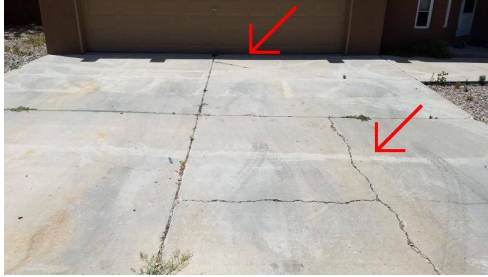
##### *2.2 Driveway Condition:*

1. Attention Needed - The driveway needs action. Repair or replacement is indicated. There is cracks and heaving noted in the driveway. These indicate movement of the soil and/or possible poor preparation of the substrate and over time may develop into trip hazards or cause other issues with uneven settlement or moisture penetration. It needs to be repaired to prevent further deterioration or a trip hazard.

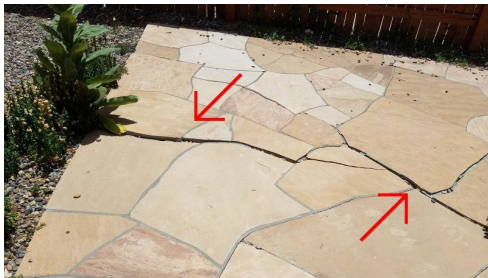
##### *5.8 Surface Condition:*

3. Attention Needed - The patio surface needs repair in order to prevent further deterioration. The inspector noted heaving flagstone that is posing trip hazards. Modifying the flagstone is needed for safety concerns.

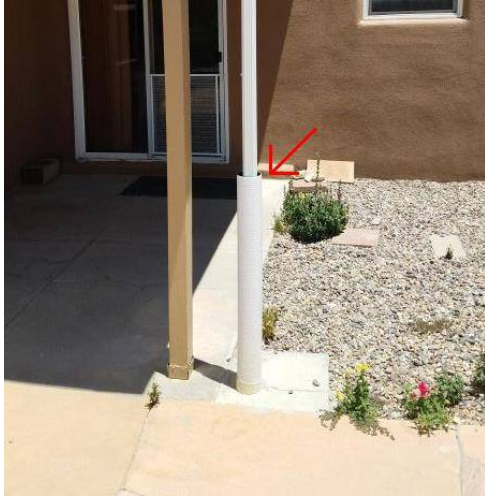
##### *6.10 Roof Drainage System Condition:*

4. Maintenance Needed - The canals are showing signs of weather related deterioration and are in need of paint/stain to help protect them from the elements. The services of a qualified handyman or painting contractor are recommended. The patio downspout goes into an underground system. I was unable to determine where it empties and if functional.

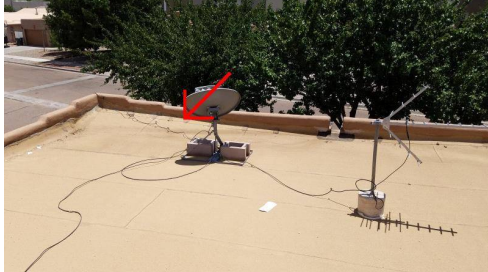
#### 6.13 *Evidence of Ponding:*

6. Attention Needed - The inspector noted evidence of ponding or pooling water on the surface of the roof. No active ponding was noted at the time of the inspection. We recommend the services of a qualified roofer for further evaluation and repair.

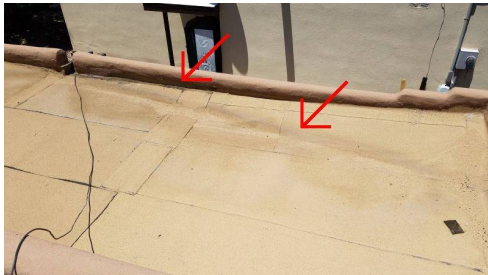
7. Evidence of ponding or pooling water on the surface of the roof.

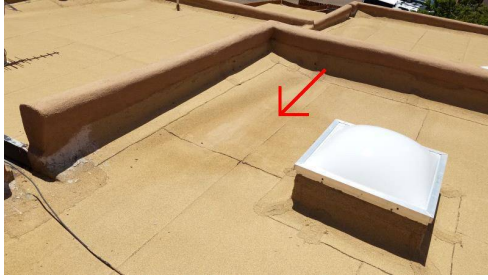
8. Evidence of ponding or pooling water on the surface of the roof.

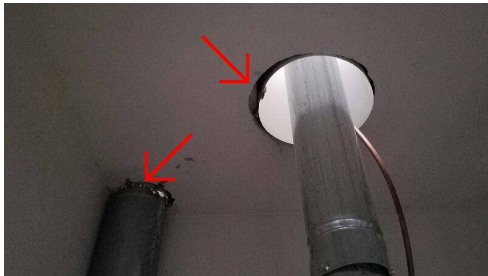
#### 8.14 Vents & Exhausts:

10. Attention Needed - The inspector noted a lack of a proper fire stop around the flue(s) for water heater and heating system. The installation of the fire stop is recommended for safety concerns and to meet the minimum building standards for safety.

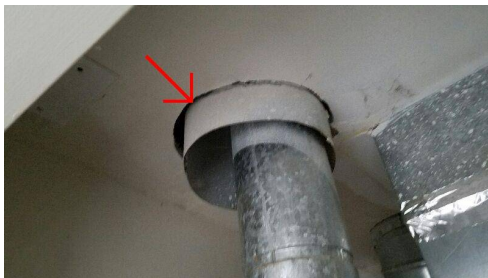
11. Lack of a fire stop noted around the heating system exhaust flu.

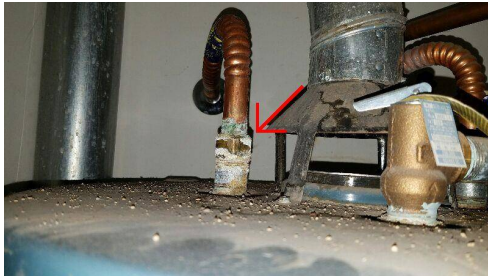
#### *12.5 Water Piping Condition:*

15. Attention Needed - The water heater plumbing is in need of attention by a qualified plumber. There is evidence of encrustation and/or mineral deposits at the top of the water heater. The services of a qualified plumber are recommended for further evaluation and repair.

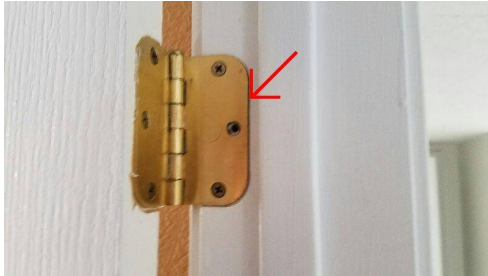
#### *18.31 Doors:*

20. Attention Needed - The door or hardware on the door to this room needs some adjustment or repair for it to function appropriately. At least one of the door hinges is loose and needs attention and repair.

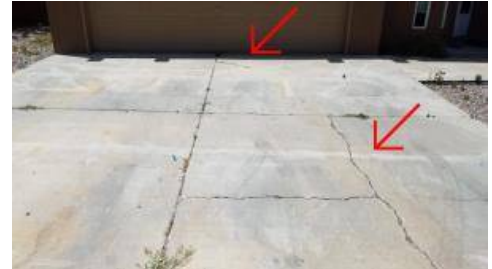
**2.2 Driveway Condition:**

Attention Needed - The driveway needs action. Repair or replacement is indicated. There is cracks and heaving noted in the driveway. These indicate movement of the soil and/or possible poor preparation of the substrate and over time may develop into trip hazards or cause other issues with uneven settlement or moisture penetration. It needs to be repaired to prevent further deterioration or a trip hazard.

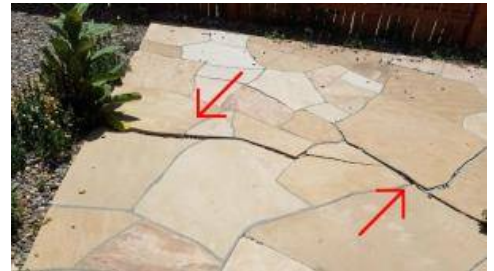
**5.8 Surface Condition:**

Attention Needed - The patio surface needs repair in order to prevent further deterioration. The inspector noted heaving flagstone that is posing trip hazards. Modifying the flagstone is needed for safety concerns.

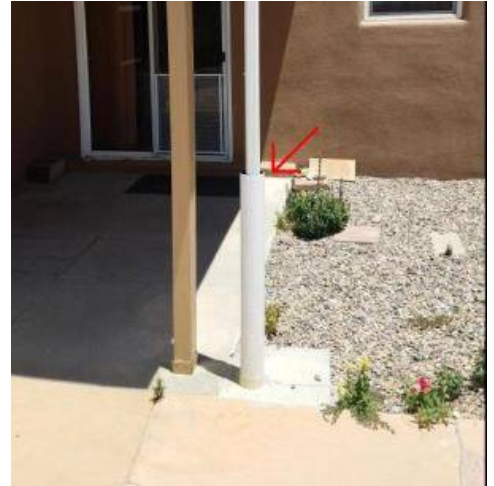
### 6.10 Roof Drainage System Condition:

Maintenance Needed - The canales are showing signs of weather related deterioration and are in need of paint/stain to help protect them from the elements. The services of a qualified handyman or painting contractor are recommended. The patio downspout goes into an underground system. I was unable to determine where it empties and if functional.

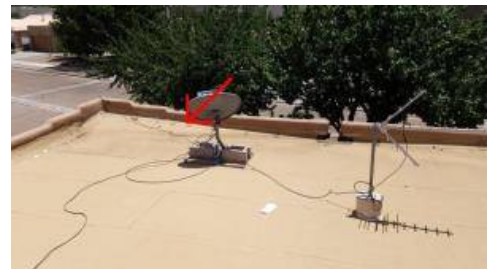
**6.13 Evidence of Ponding:**

Attention Needed - The inspector noted evidence of ponding or pooling water on the surface of the roof. No active ponding was noted at the time of the inspection. We recommend the services of a qualified roofer for further evaluation and repair.

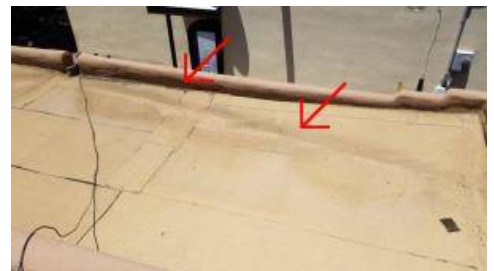
Evidence of ponding or pooling water on the surface of the roof.

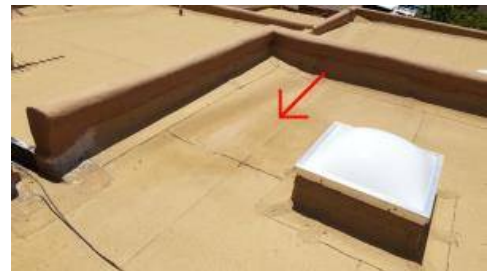
Evidence of ponding or pooling water on the surface of the roof.

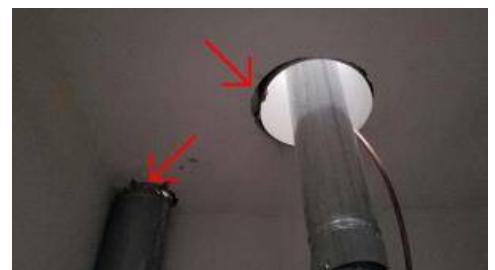
**8.14 Vents & Exhausts:**

Attention Needed - The inspector noted a lack of a proper fire stop around the flue(s) for water heater and heating system. The installation of the fire stop is recommended for safety concerns and to meet the minimum building standards for safety.

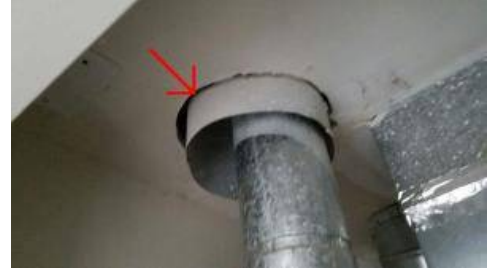
Lack of a fire stop noted around the heating system exhaust flu.

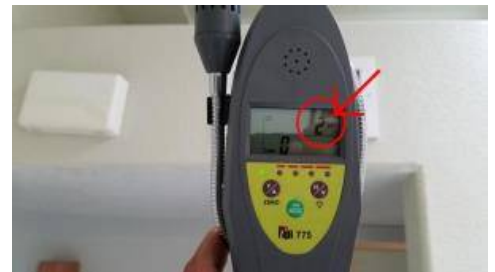
#### Tested:

Action Needed - Measurable amounts of carbon monoxide were noted from the registers. A hazardous condition may exist. Thebinsoectie noted readings of 1-3 PPM. Further testing and evaluation are needed.

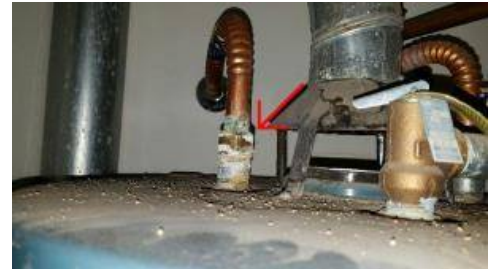
### 12.5 Water Piping Condition:

Attention Needed - The water heater plumbing is in need of attention by a qualified plumber. There is evidence of encrustation and/or mineral deposits at the top of the water heater. The services of a qualified plumber are recommended for further evaluation and repair.

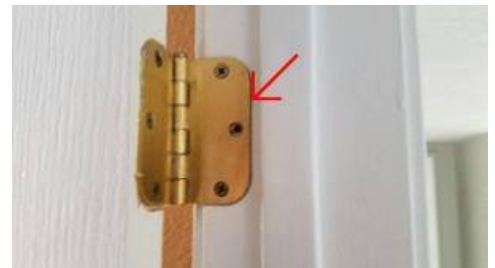
**18.31 Doors:**

Attention Needed - The door or hardware on the door to this room needs some adjustment or repair for it to function appropriately. At least one of the door hinges is loose and needs attention and repair.
